U.S. CHEMICAL SAFETY AND HAZARD INVESTIGATION BOARD

INVESTIGATION REPORT

REFINERY EXPLOSION AND FIRE

REPORT NO. 2005-04-I-TX

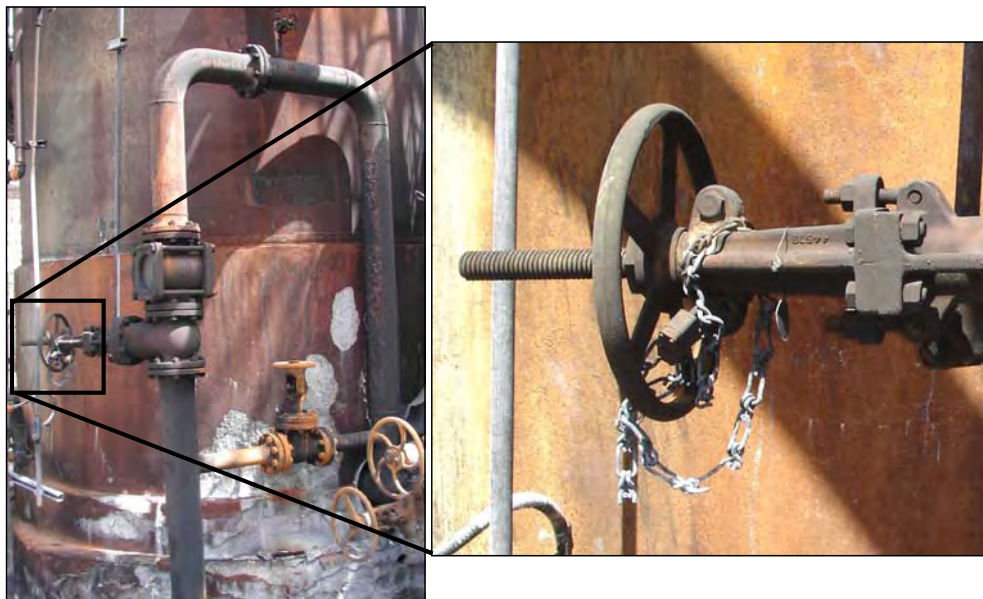
Figure 4. Left: Gooseneck piping and manual block valve (chained-locked open) Right: Close-up of manual block valve

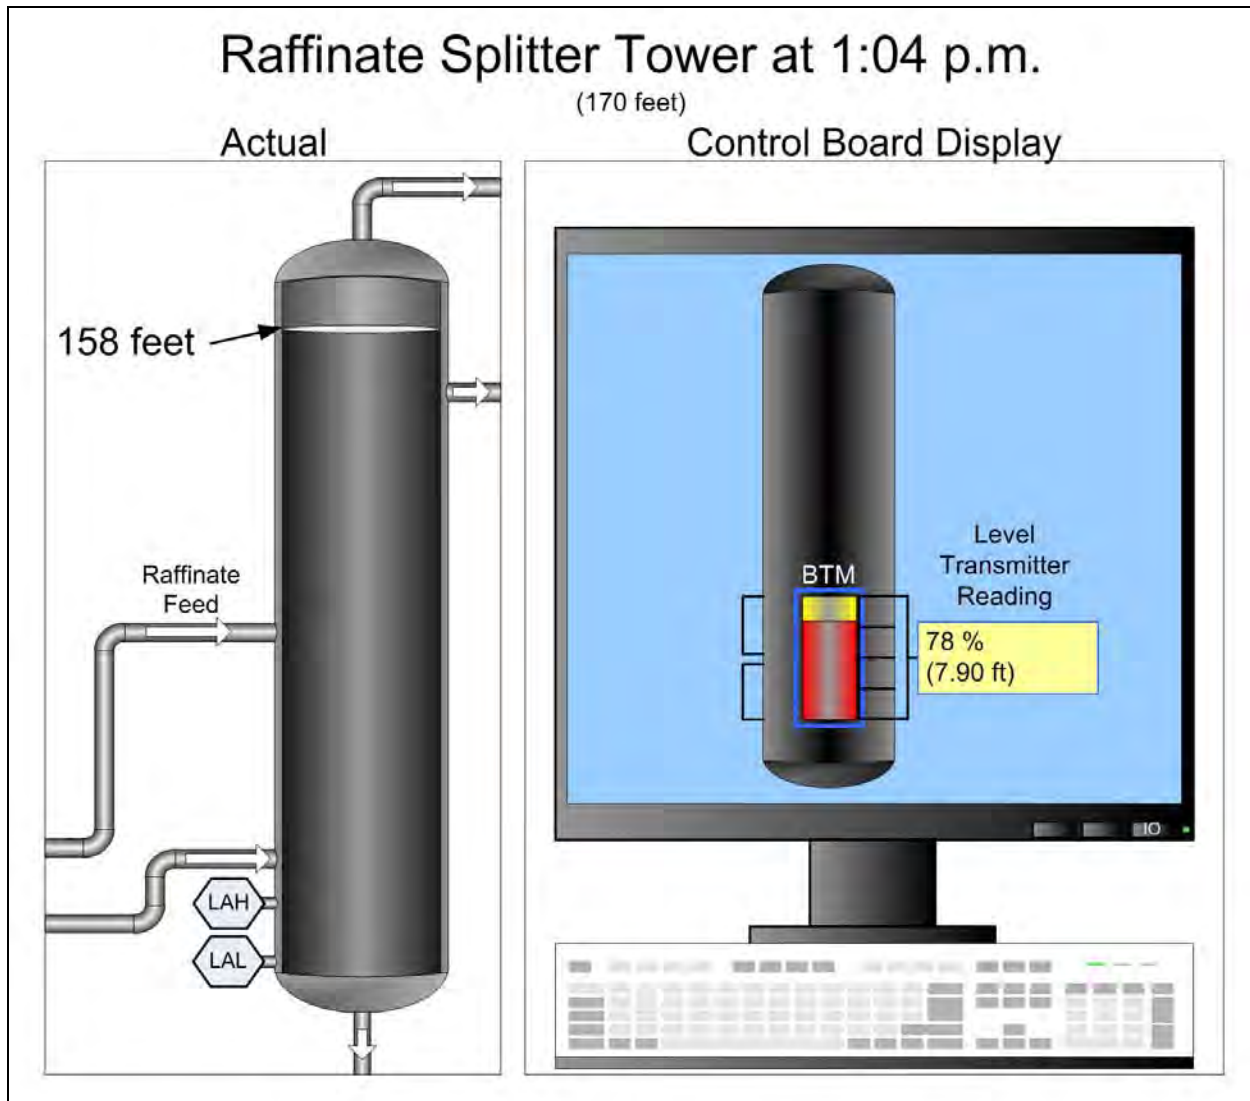
Figure 6. At 1:04 p.m. the liquid level in the tower was 158 feet (48 m), but the computerized control system indicated to operators that the level was at 78 percent of the level transmitter (7.9 feet, or 2.4 m, of liquid in the tower).

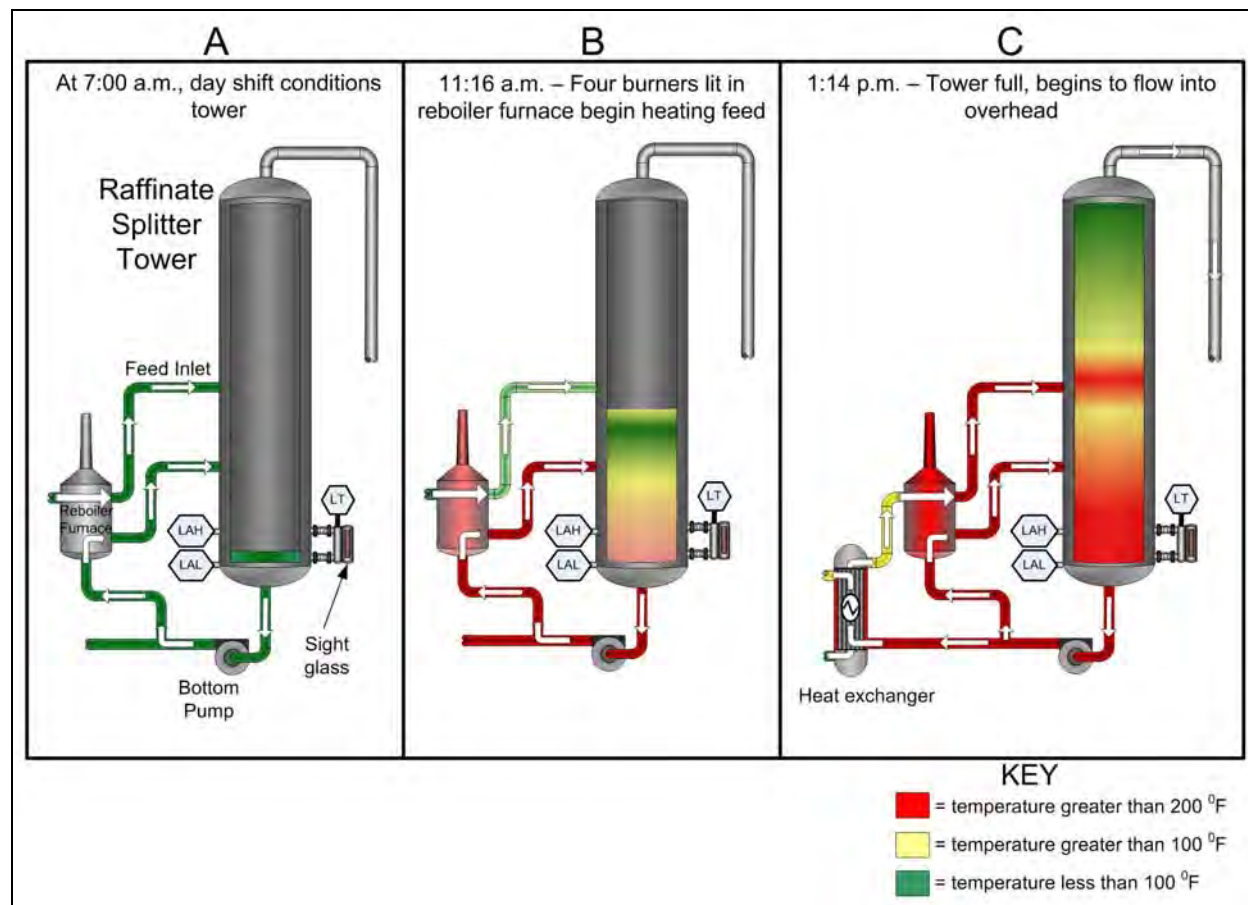
At 1:14 p.m., sub-cooled⁴³ hydrocarbon liquid flowed out of the top of the raffinate splitter tower and into the vertical overhead vapor line, due to overflowing and rapid heating of the column (Figure 7).

Figure 7. Heating of feed in the splitter tower

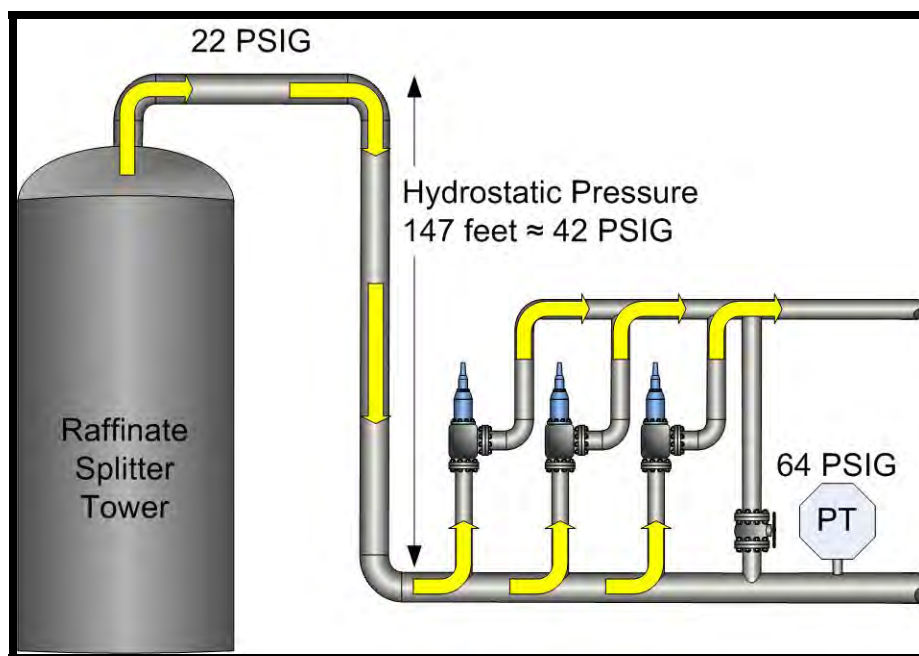
Figure 8. Hydrostatic head of liquid in overhead piping leads to the three relief valves opening

The minimum closing (blowdown) pressure for the three safety relief valves to stop flowing was 37.2 psig (256.5 kPa). Computerized control system data indicate that all three safety relief valves were fully open and flowing at capacity for slightly longer than six minutes. An average pressure of 61 psig (421 kPa) at

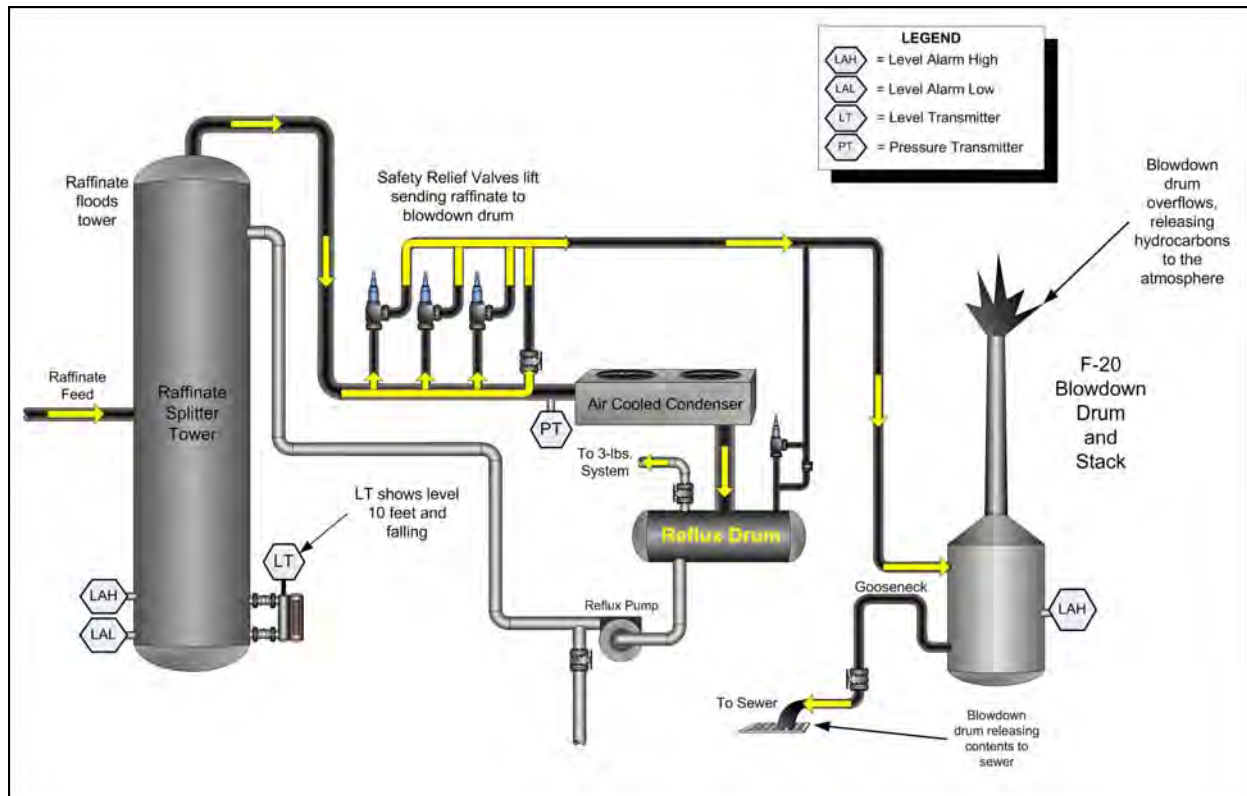
Once the blowdown system filled, flammable liquid discharged to the atmosphere from its stack as a geyser and fell to the ground (Figure 9). Shortly after the ISOM operators began troubleshooting the pressure spike, they received, via radio, the first notification that the blowdown drum was overflowing. In response to the radio message, the Board Operator and Lead Operator used the computerized control system to shut the flow of fuel to the heater, while the other operators left the satellite control room and ran toward an adjacent road, Avenue F, to re-direct traffic away from the blowdown drum, as required by BP's "Emergency Response Procedure A-7."

Figure 9. Tower overfills and blowdown drum releases hydrocarbons

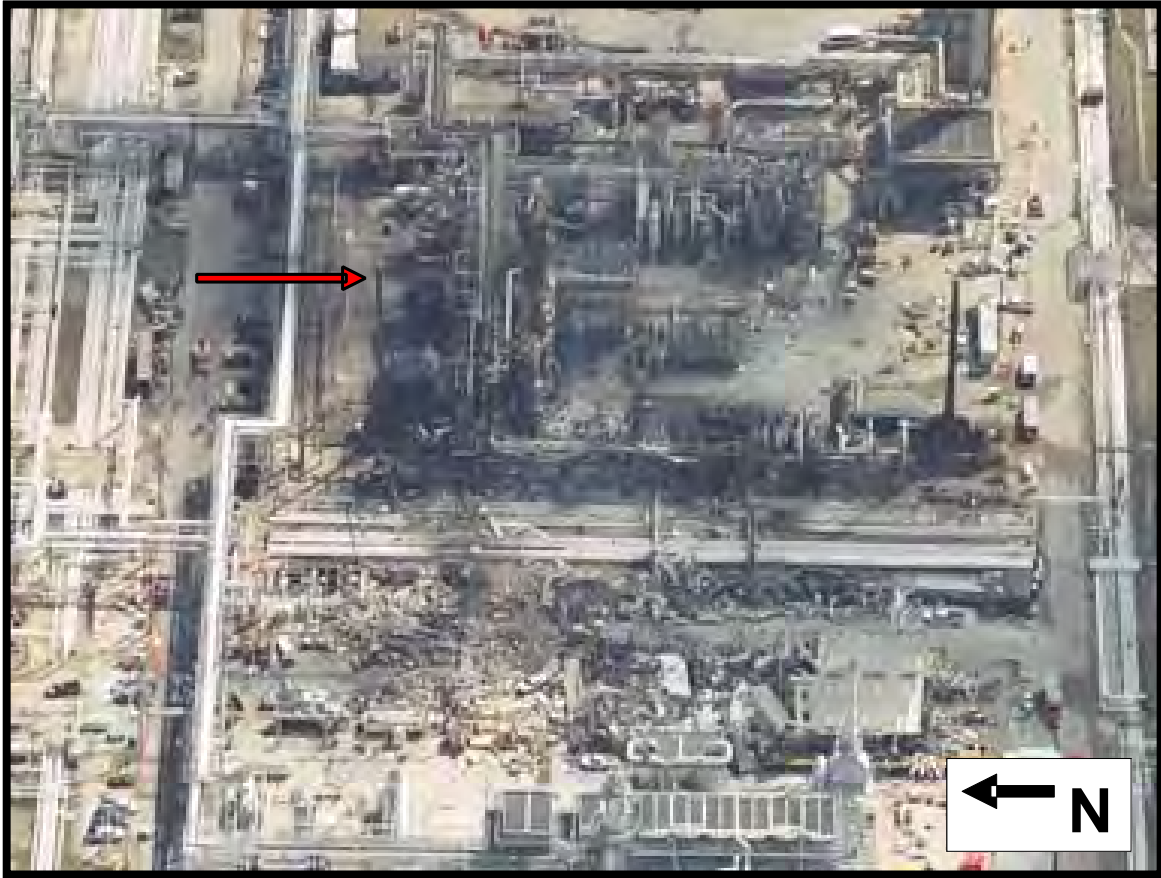
Figure 10. The darkened areas in and around the ISOM unit had the heaviest fire damage; the red arrow points to the top of the blowdown stack

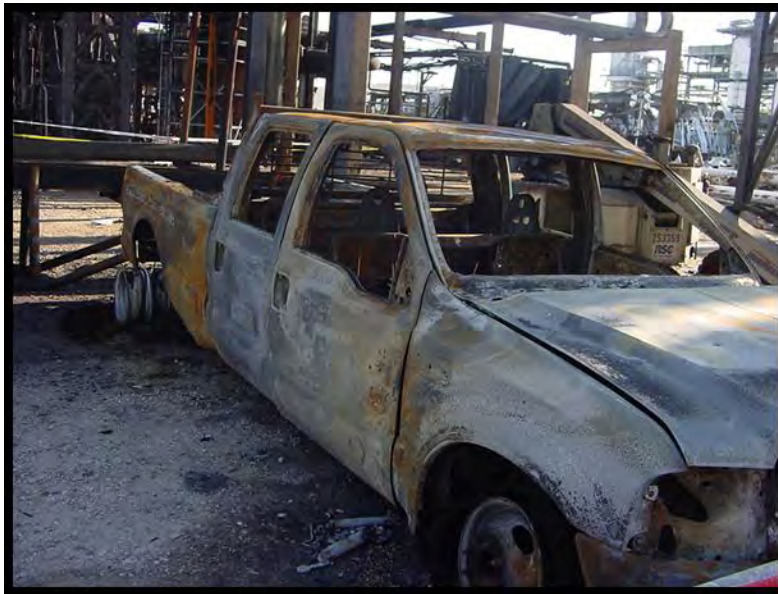
Although several potential ignition sources (Appendix H.16) were identified, the most likely ignition point was an idling diesel pickup truck (Figure 11). This truck was parked about 25 feet (7.6 m) from the blowdown drum, and several eyewitnesses reported seeing or hearing the truck's engine over-revving when the vapor cloud reached it.

Figure 11. Idling diesel pickup truck at north end of ISOM unit

Two eyewitnesses saw the truck catch fire, followed shortly by the vapor cloud explosion. One eyewitness saw sparks leaving the truck after a backfire and igniting the vapor cloud. While the diesel pickup has been positively identified by witnesses as an ignition point, this does not preclude the potential that the cloud was additionally ignited by other sources.

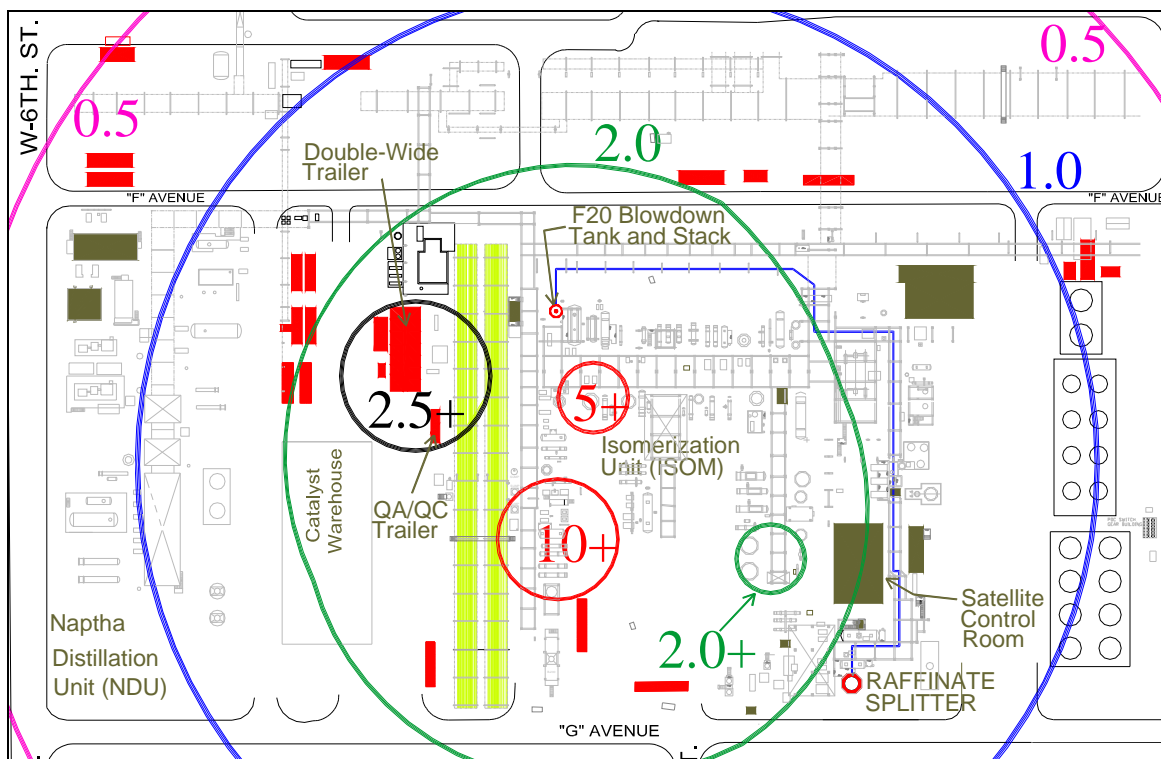
congestion/confinement and flammable mix allowed, greatly intensifying the blast pressure in certain areas. These intense pressure regions, or sub-explosions, produced heavy structural damage locally and left a pattern of structural deformation away from the blast center in all directions. A computer simulation⁴⁹ and a blast overpressure map (Figure 12) were developed based on site observations, structural analysis, and blast modeling (Appendix H).

Figure 12. Blast overpressure map depicting the areas of highest blast pressure (10+, 5+, and 2.5+ psi)

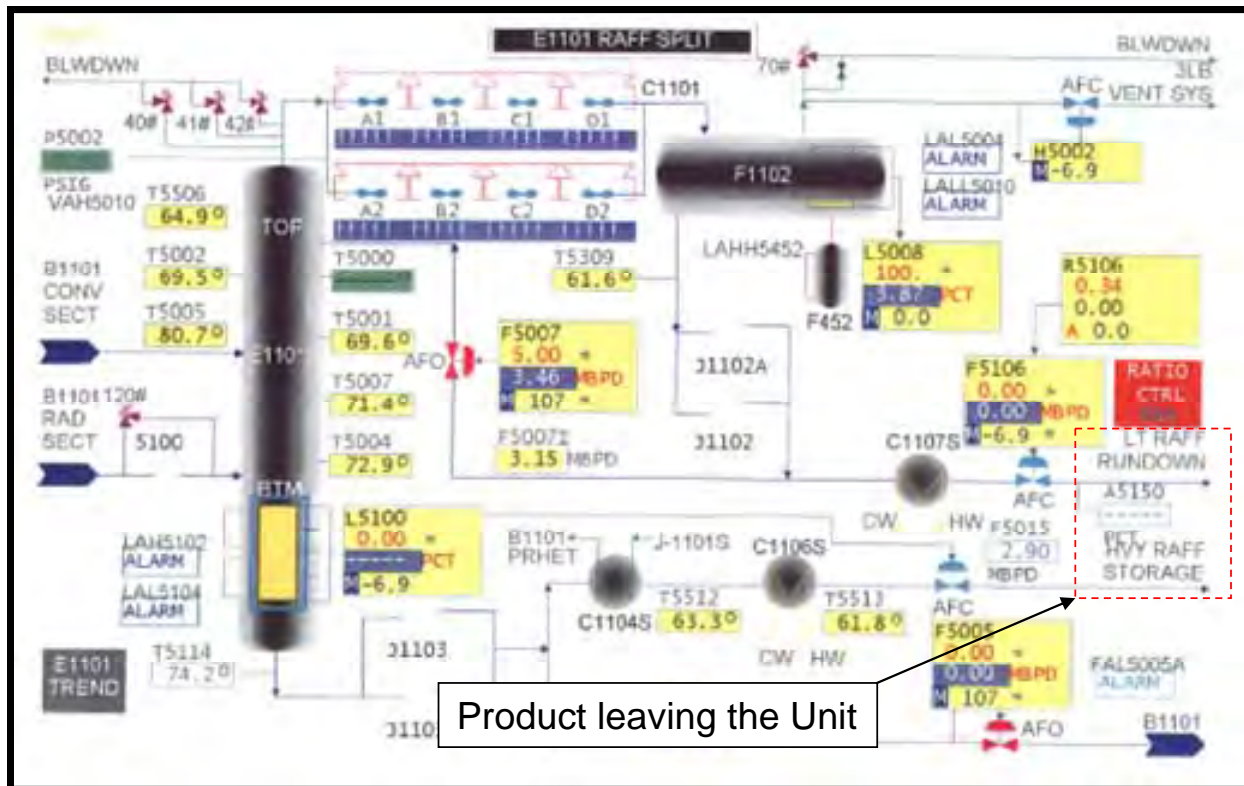
Figure 14. The Board Operator viewed this screen, which provides information on raffinate product leaving the unit but not the liquid being added to the unit.

A poorly designed computerized control system display was found to be a cause in another major incident, the 1994 [explosions and fire at a Texaco plant in Milford Haven](#), in the United Kingdom. The control system did not calculate the material balance of the system and the operators did not know how to make such calculations. The computerized control system was also configured to display only portions of the unit in discrete detailed sections, and did not allow for a complete overview of the process, just like the control system screens for the Texas City ISOM unit. The U.K. Health and Safety Executive⁸³ recommended that computerized control systems include a process overview and, as appropriate, material balance summaries to ensure full process oversight by operators (HSE, 1997).

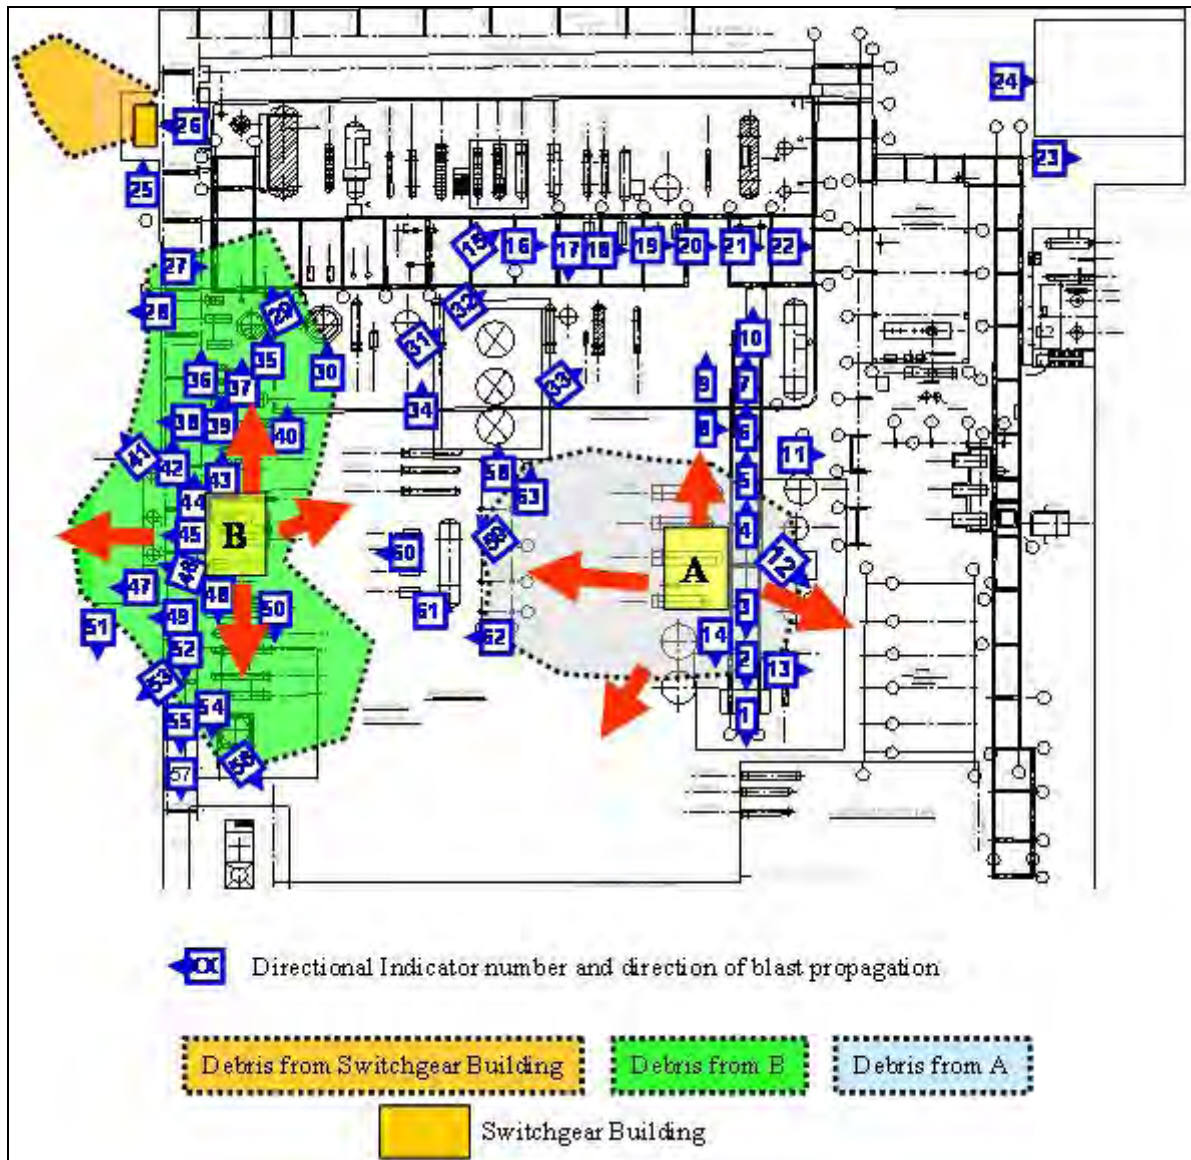
- Areas surrounding the intense pressure regions in the ISOM unit, including the satellite control building, experienced 5 psi and greater overpressures.
- The catalyst warehouse and the six temporary trailers sited directly north of it experienced approximately 2 to 2.5 psi overpressure.
- The east edge of the NDU, first layer of storage tanks south of Ave. G, and the south edge of the ULC unit experienced about 1 psi overpressure.
- The west edge of the NDU, second layer of tanks south of Ave. G, the south portions of ULC and ARU units, and the western edge of the ARU unit experienced 0.5 psi and greater overpressures.
- Five ULC turnaround trailers sited west of Sixth Street; the remainder of ULC and ARU units, and storage tanks farther south experienced 0.25 psi and greater overpressures.

Figure H- 1. Intense blast regions in the ISOM unit

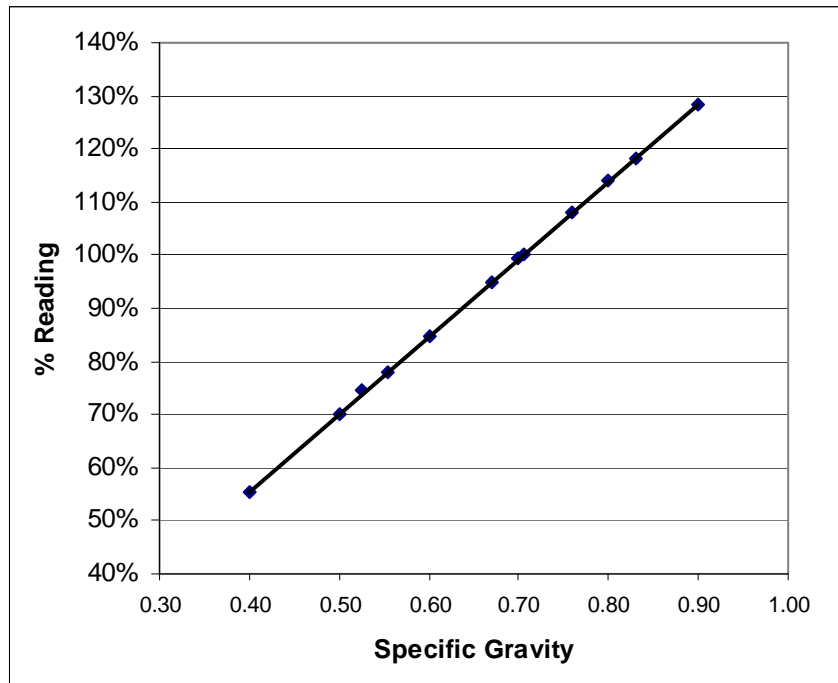
Figure S- 1. Calculated LT-5100 flooded reading versus specific gravity

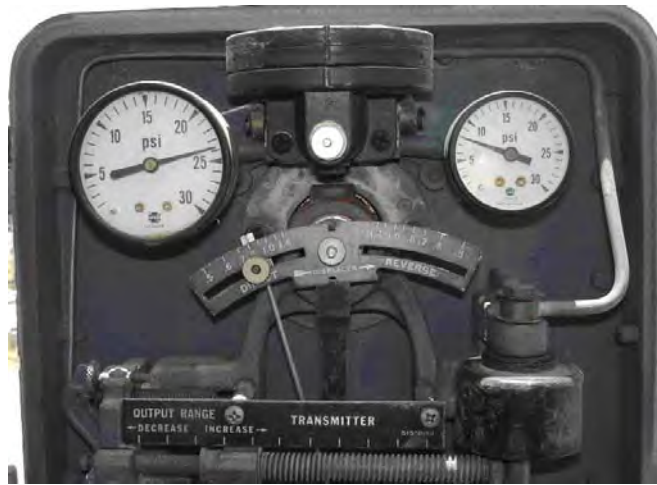
The CSB investigators learned that the instrument data sheet, which should have been used for calibrating the transmitter, had not been updated since 1975 when the tower was part of a different process with a different feed fluid. The data sheet had never been changed to reflect the operating specific gravity in the ISOM process; furthermore, instrument technicians responsible for maintaining and calibrating the transmitter stated that the data sheets—even if they had been updated—were unavailable to them. The CSB learned that these data sheets were filed in an engineer’s office and were not typically given to technicians with work orders for instrument calibration.

Figure S- 3. LT-5100 cabinet showing calibration set for 0.8 specific gravity

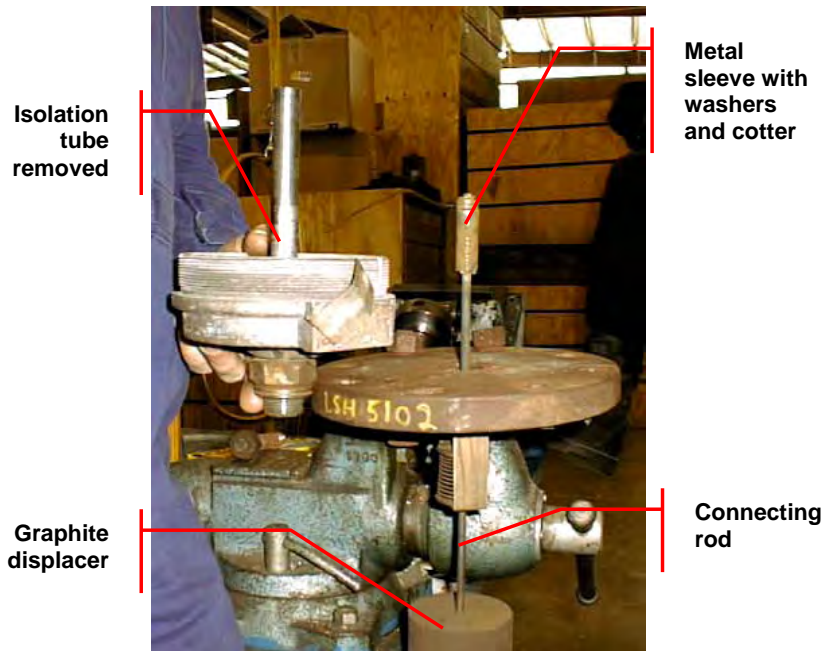
Figure S- 4. LSH-5102 internal components

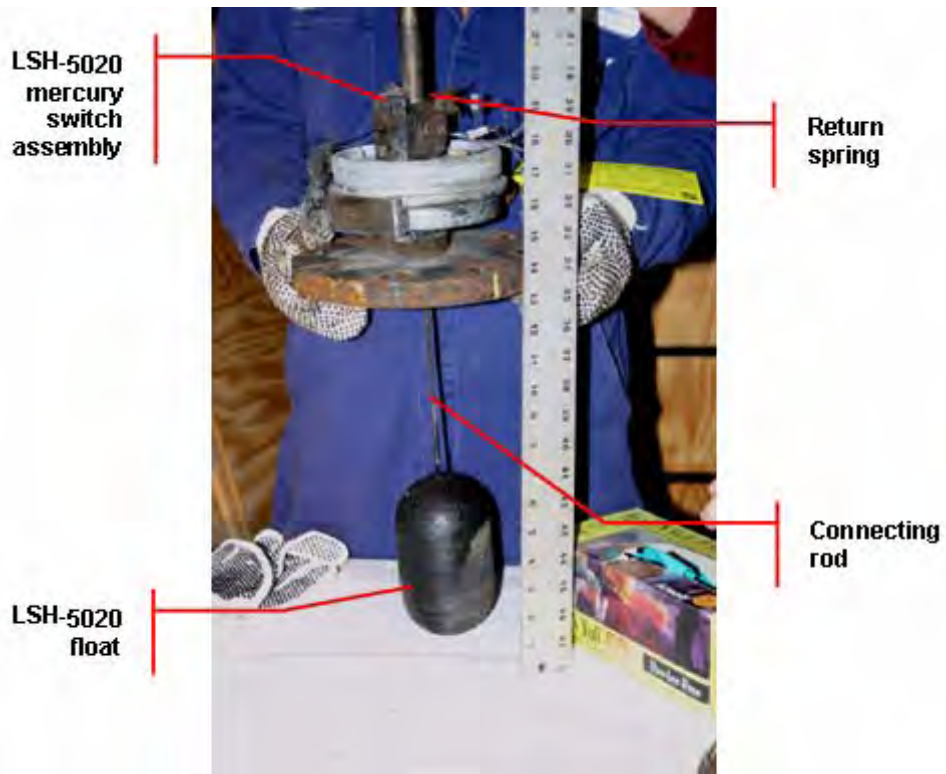
Figure S- 5. Internal components of LSH-5020 blowdown drum high level alarm

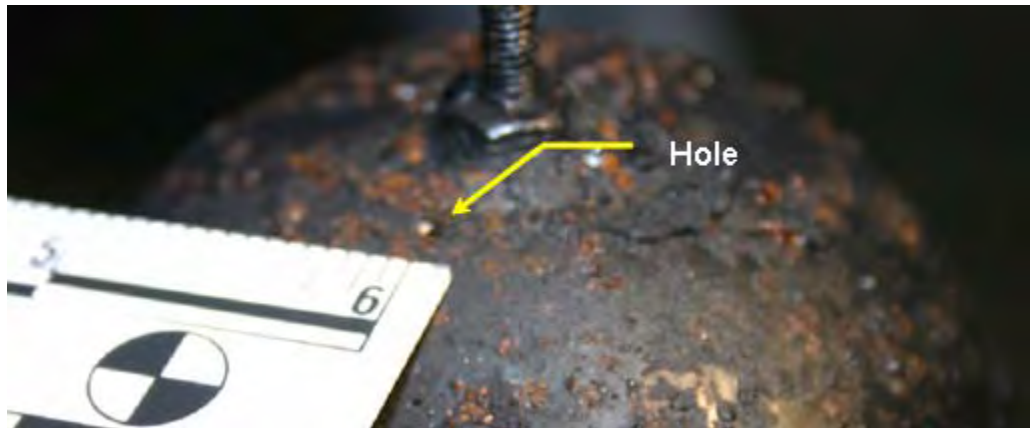
Figure S- 6. Close-up of LSH-5020 float, showing corrosion and hole

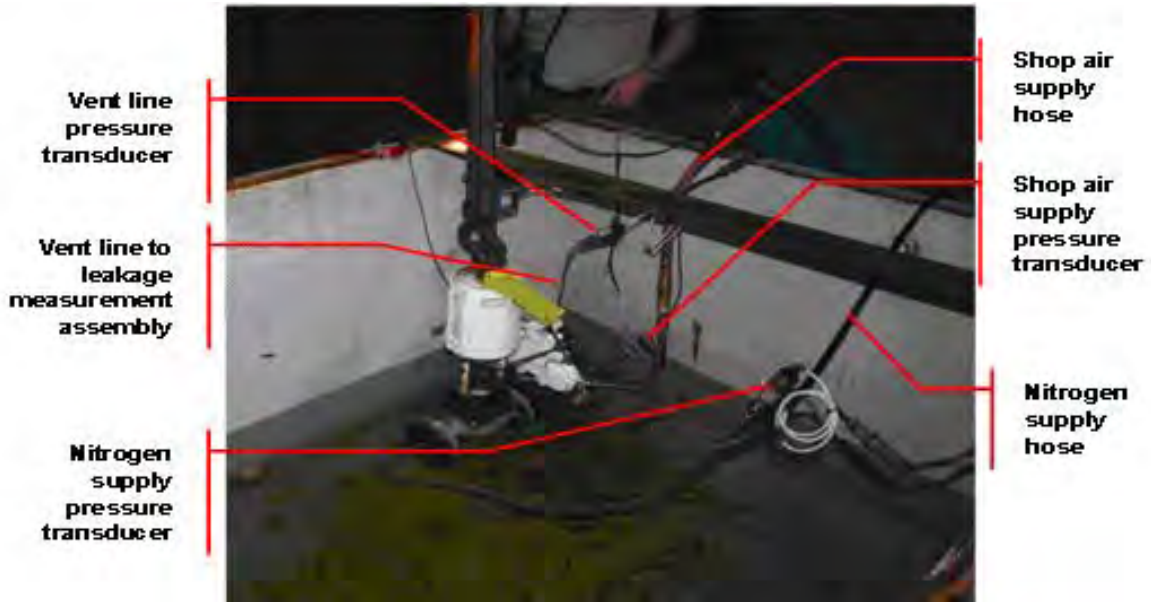
Figure S- 7. PCV-5002 shop testing
