# **FINAL INVESTIGATION REPORT**

## **CARIBBEAN PETROLEUM TANK TERMINAL EXPLOSION AND MULTIPLE TANK FIRES**

### **CARIBBEAN PETROLEUM CORPORATION (CAPECO)**

REPORT NO. 2010.02.I.PR

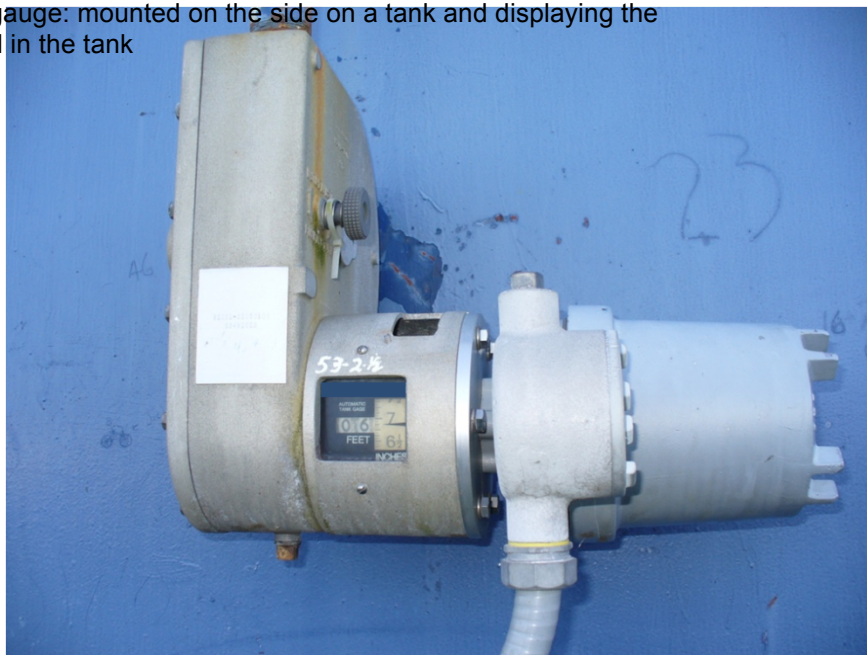
Figure 4: Side gauge: mounted on the side on a tank and displaying the amount of liquid in the tank

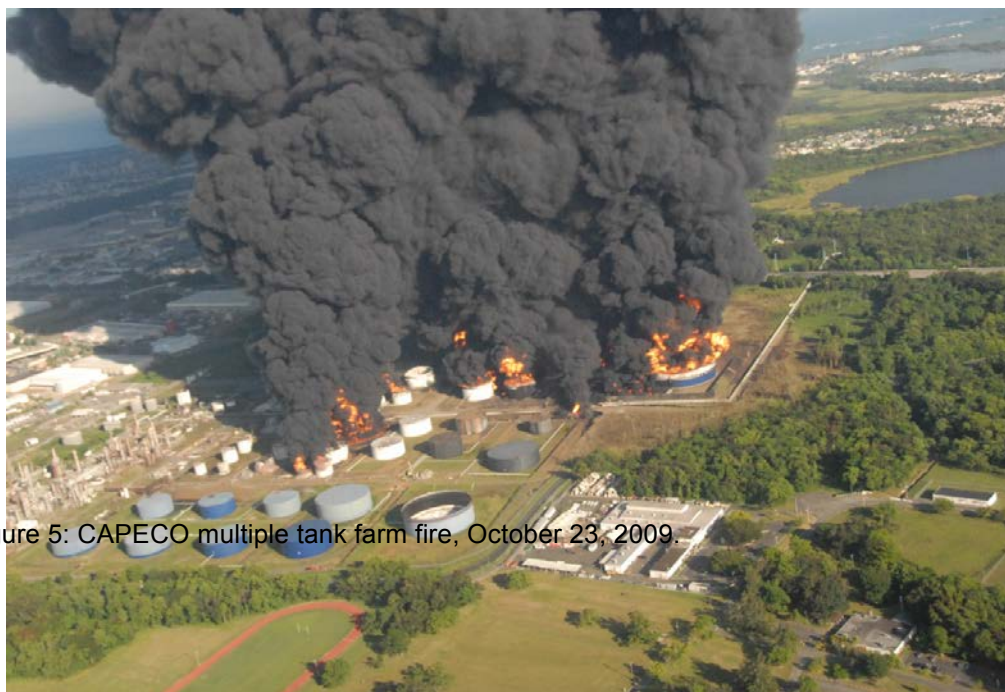
After the explosion, fuel in the damaged tanks burned for over two days while emergency responders fought to control the fire and prevent other tanks from igniting. The large fire demanded emergency personnel and resources from across the Commonwealth of Puerto Rico and the US mainland. Local fire departments with assistance from an industrial firefighting company took 66 hours to extinguish the fire after the explosion. As a result, 17 of the 48 tanks burned. (See Figures 5 and 6.)

Figure 5: CAPECO multiple tank farm fire, October 23, 2009.

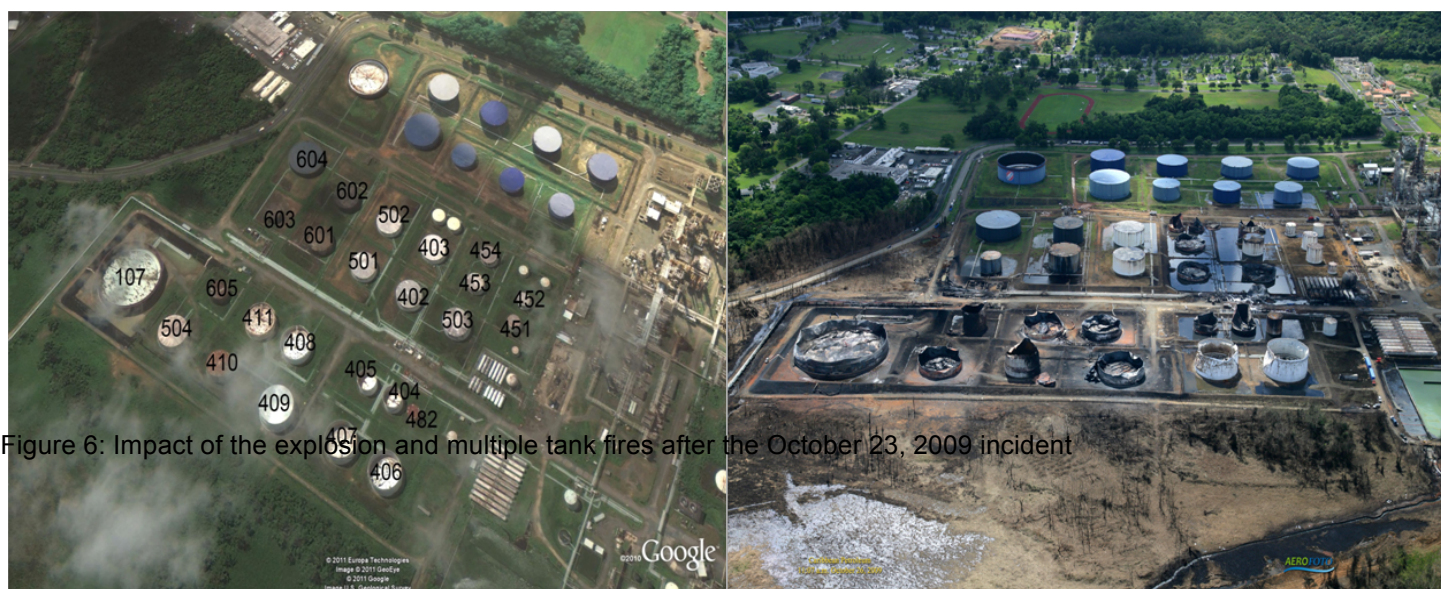
Figure 6: Impact of the explosion and multiple tank fires after the October 23, 2009 incident

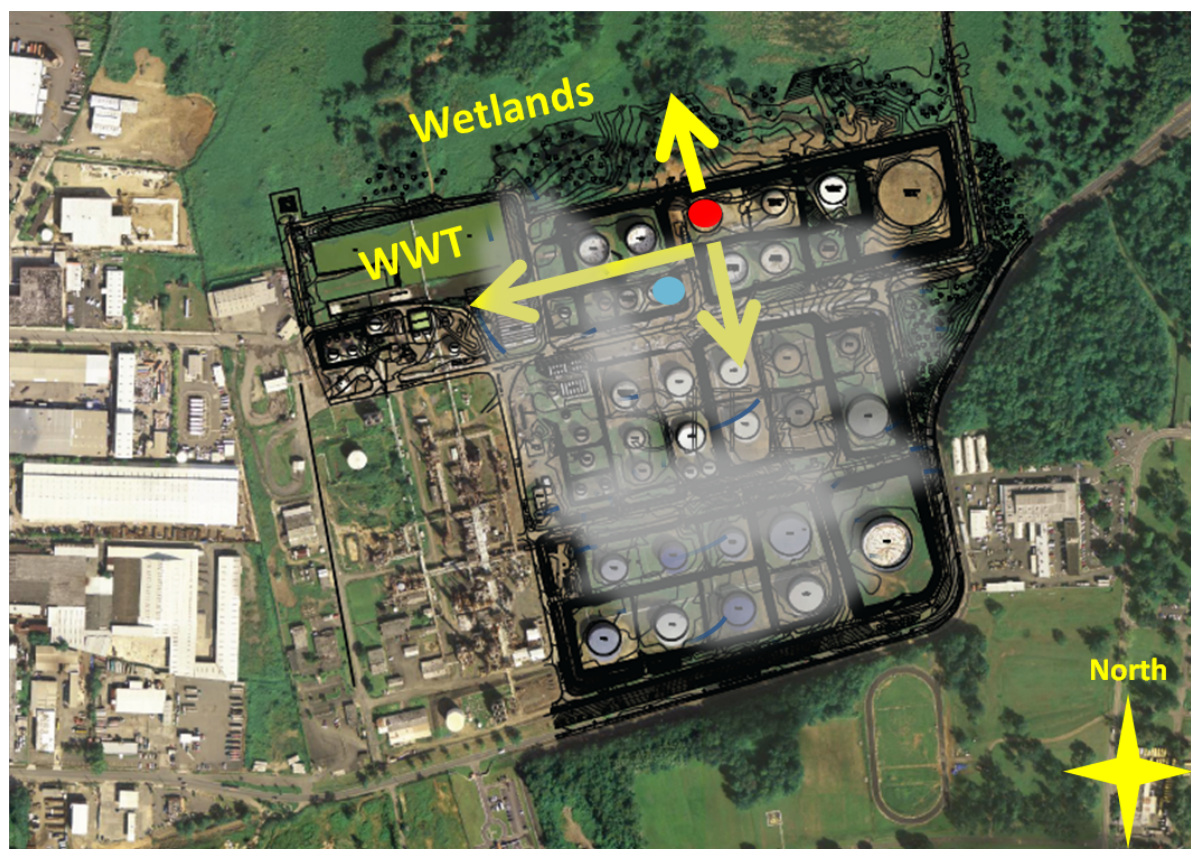
Figure 7. Topographic Survey of CAPECO Tank Farm showing the gasoline vapor cloud migration from higher elevation (Tank 409-Red and Tank 411-Blue) toward low-lying areas by the WWT plant, the south eastern end of the refinery and wetlands to the north. The cloud indicates the approximate area where the vapor cloud migrated based on surveillance footage.

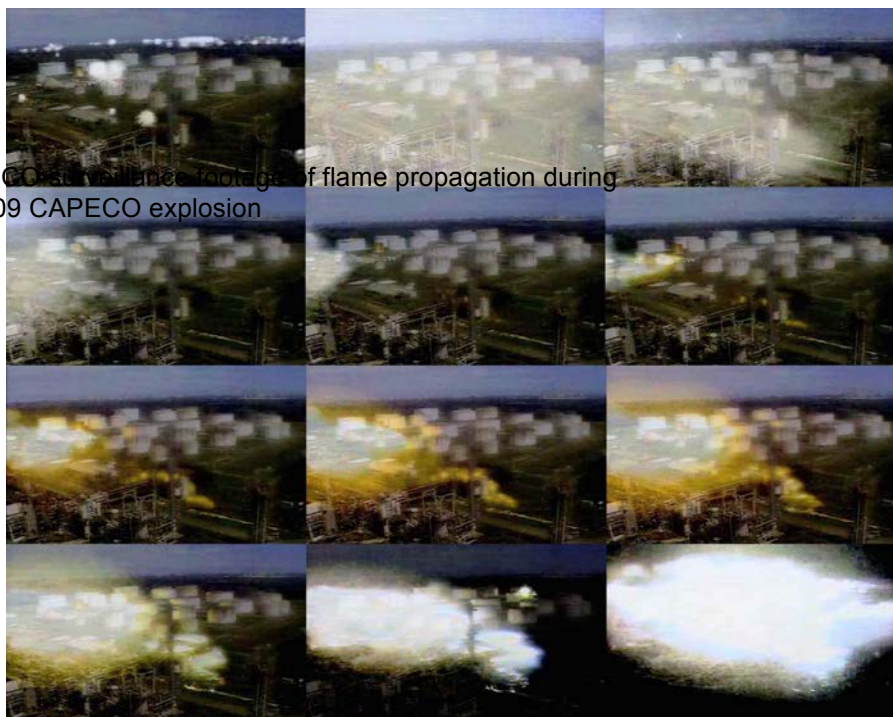
Figure 8: CAPECO onsite surveillance footage of flame propagation during October 23, 2009 CAPECO explosion

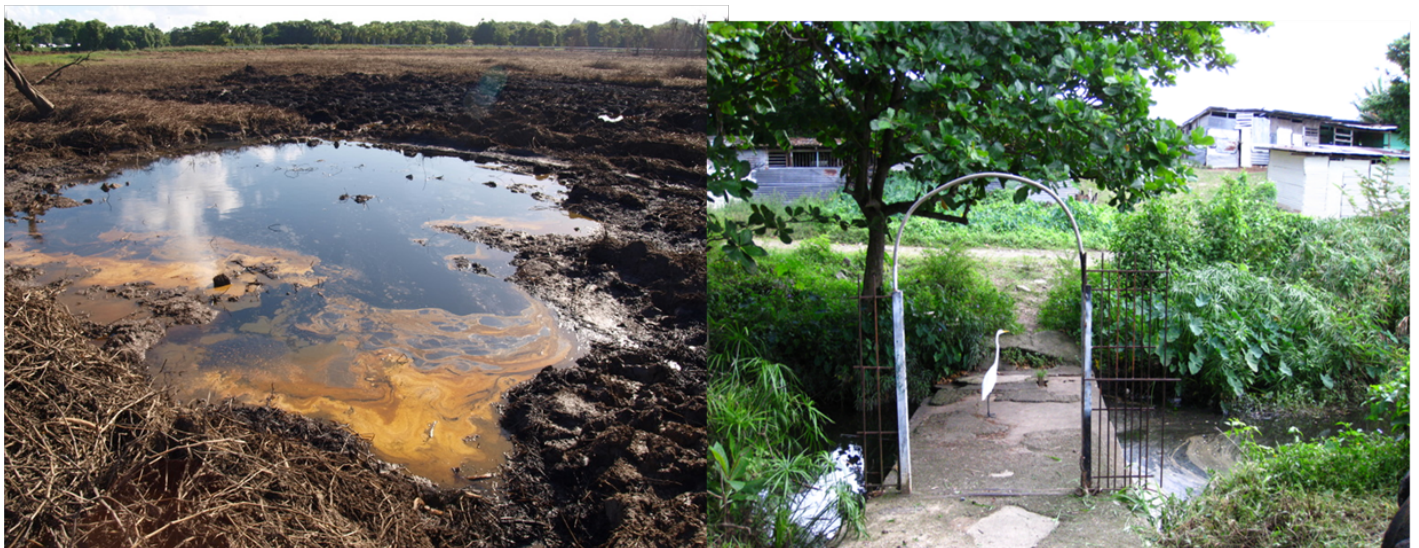
Fort Buchanan experienced the most severe damage—suffering an estimated \$5 million in repair costs. Community impact assessments<sup>39</sup> found most of the structural damage occurred in the Puente Blanco neighborhood where PREMA and the Department of Housing (DOH) found damage to 232 of the 266 homes assessed; 139 were repaired and six were demolished by November 2009.<sup>40</sup> The Puente Blanco community also experienced environmental contamination to several surface water bodies, including federally protected wetlands and streams surrounding the CAPECO site. After assessing 289 homes damaged by the explosion in the Cataño community, the Small Business Administration (SBA)<sup>41</sup> designated 25 single-family homes as destroyed or severely damaged at or beyond 40% of their fair market value. (See Figure 10.)

Figure 10: Community damage surrounding the CAPECO facility

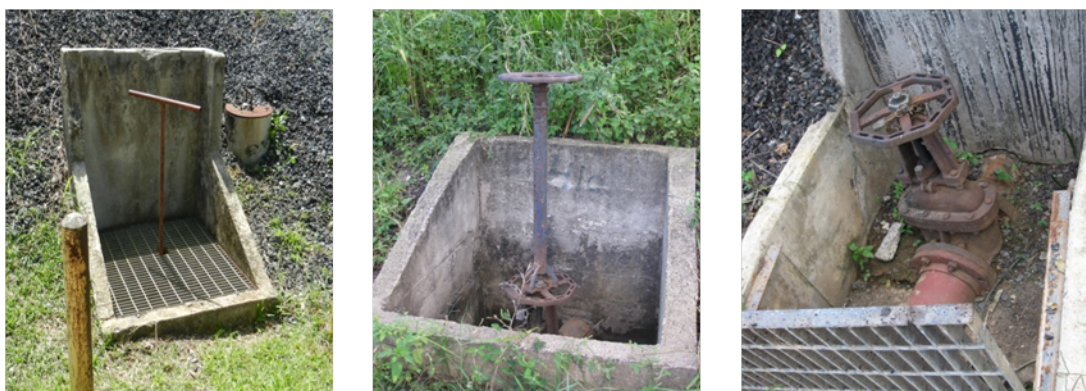
CAPECO's normal practices required operators to open and close valves during the day shifts. Operators customarily inspected whether the dike drain valves were open or closed from their vehicles as they drove by. The tank farm used both rising stem and fixed stem valves on the dike drains leading to the storm water retention pond in the WWT area. Rising stem valves allowed operators to easily observe the open or closed position while fixed stem valves do not provide a visual indication of the position. The fixed stem valve on the dike drain for Tank 409 made it difficult for tank farm operators to observe its position without physically turning it. (See Figure 15.) In some cases, the valve position could not be determined with a visual inspection because the rising stem valve position was hidden in the sump. (See Figure 15, center photo.) Furthermore, none of the dike valves shown in Figure 15 were consistent with RAGAGEP. Regulatory coverage under the EPA Risk Management Plan (RMP) or OSHA's Process Safety Management (PSM) Standard requires that CAPECO use the best available engineering practices to assess valve open/close status.

Figure 15: Various dike drain valves at CAPECO. Tank 409 fixed stem dike drain valve (left): position of the valve is undeterminable without physically turning the valve. Rising stem valves (center, right). In some cases, the valve position is hidden in the sump (center).
