Iso-Butylene Gas Explosion

EPSC Learning Sheet April 2024

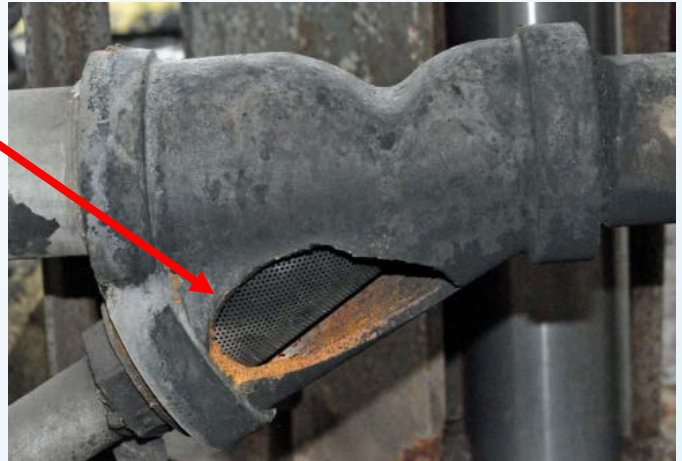
A Y shaped strainer (filter) in a three-inch pipe, ruptured. The failure occurred after pressure cycles, induced by thermal expansion. The released isobutylene resulted in a gas-cloud explosion and bankruptcy of the company.

Photo from CSB report

- When a closed system that is filled with a liquid hydrocarbon, raises in temperature, the pressure can rise above design.
- Here a brittle fatigue failure occurred in the strainer made from iron cast. More ductile materials are recommended for systems that handle hazardous materials under pressure.
- Sometimes valves are made locked open, to allow for expansion.
- Thermal relief valves can be added to system that might be liquid full and blocked in by closed valves.
- Establish criteria for each plant when thermal relief valves have to be included – depending on volume, liquid, construction material, expected temperature changes.
