# Safety Bulletin

## Key Lessons for Preventing Incidents When Preparing Process Equipment for Maintenance

### Flash Fire at the Delaware City Refinery

No. 2015-01-I-DE

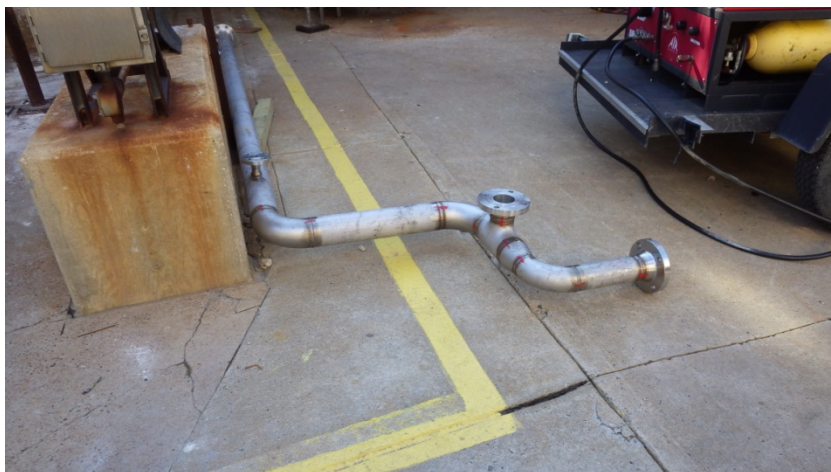
**FIGURE 2.** 20-foot replacement piping (Source: CSB).

On the day of the incident, alkylation unit operators were preparing equipment for turnover to the maintenance department, scheduled for the following day. The unit remained under the operations staff control throughout the equipment preparation activity, up to and including when the incident occurred. The maintenance activity involved replacing a 20-foot section of thinning piping located between the caustic settler drain line and the caustic recirculation pump (Figure 1) that was identified during a routine inspection process a month prior (Figure 2).

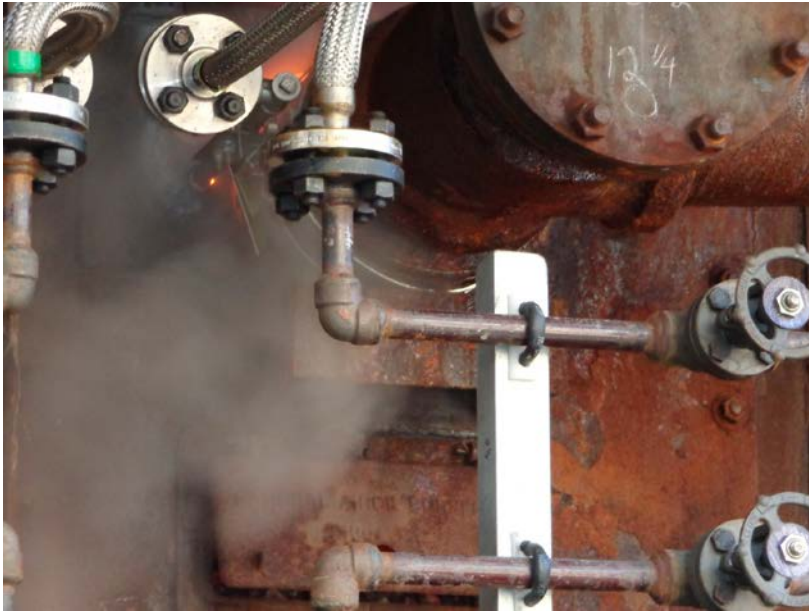
**FIGURE 7.** Burner on furnace (Source: CSB).

<sup>10</sup> The investigation team concluded that the furnace, operating on an adjacent process unit downwind of the maintenance preparation activity, was the most likely source of ignition. The injured operator recalled the fire advancing toward him from the direction of the furnace. Isobutane vapors are known to travel to the source of ignition and flash back. The atmospheric conditions on the day of the incident would have allowed for the isobutane vapors to travel in the direction of the furnace.

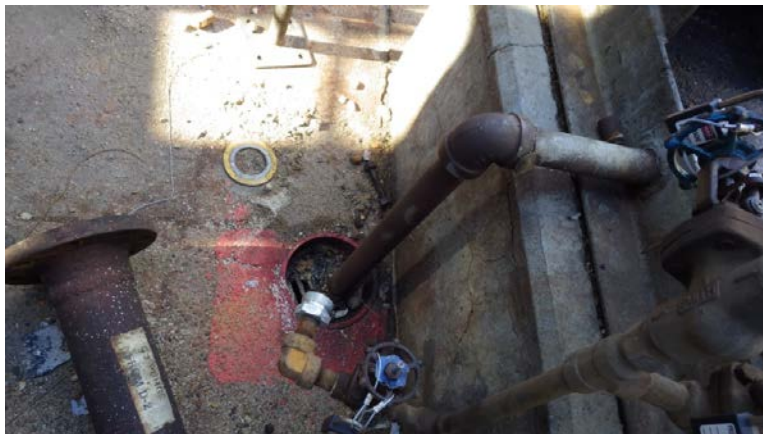
**FIGURE 8.** Typical pump drain to OWS (Source: CSB).

During the incident, fires were observed at multiple 4-inch OWS drains located at most of the pump stations between the OWS drain under the caustic settler and a furnace. The furnace was operating about 120 feet east of the caustic settler. Another operator was making rounds in the alkylation unit and responded to the fire along with
