U.S. CHEMICAL SAFETY AND HAZARD INVESTIGATION BOARD

INVESTIGATION REPORT

REFINERY EXPLOSION AND FIRE

REPORT NO. 2005-04-I-TX

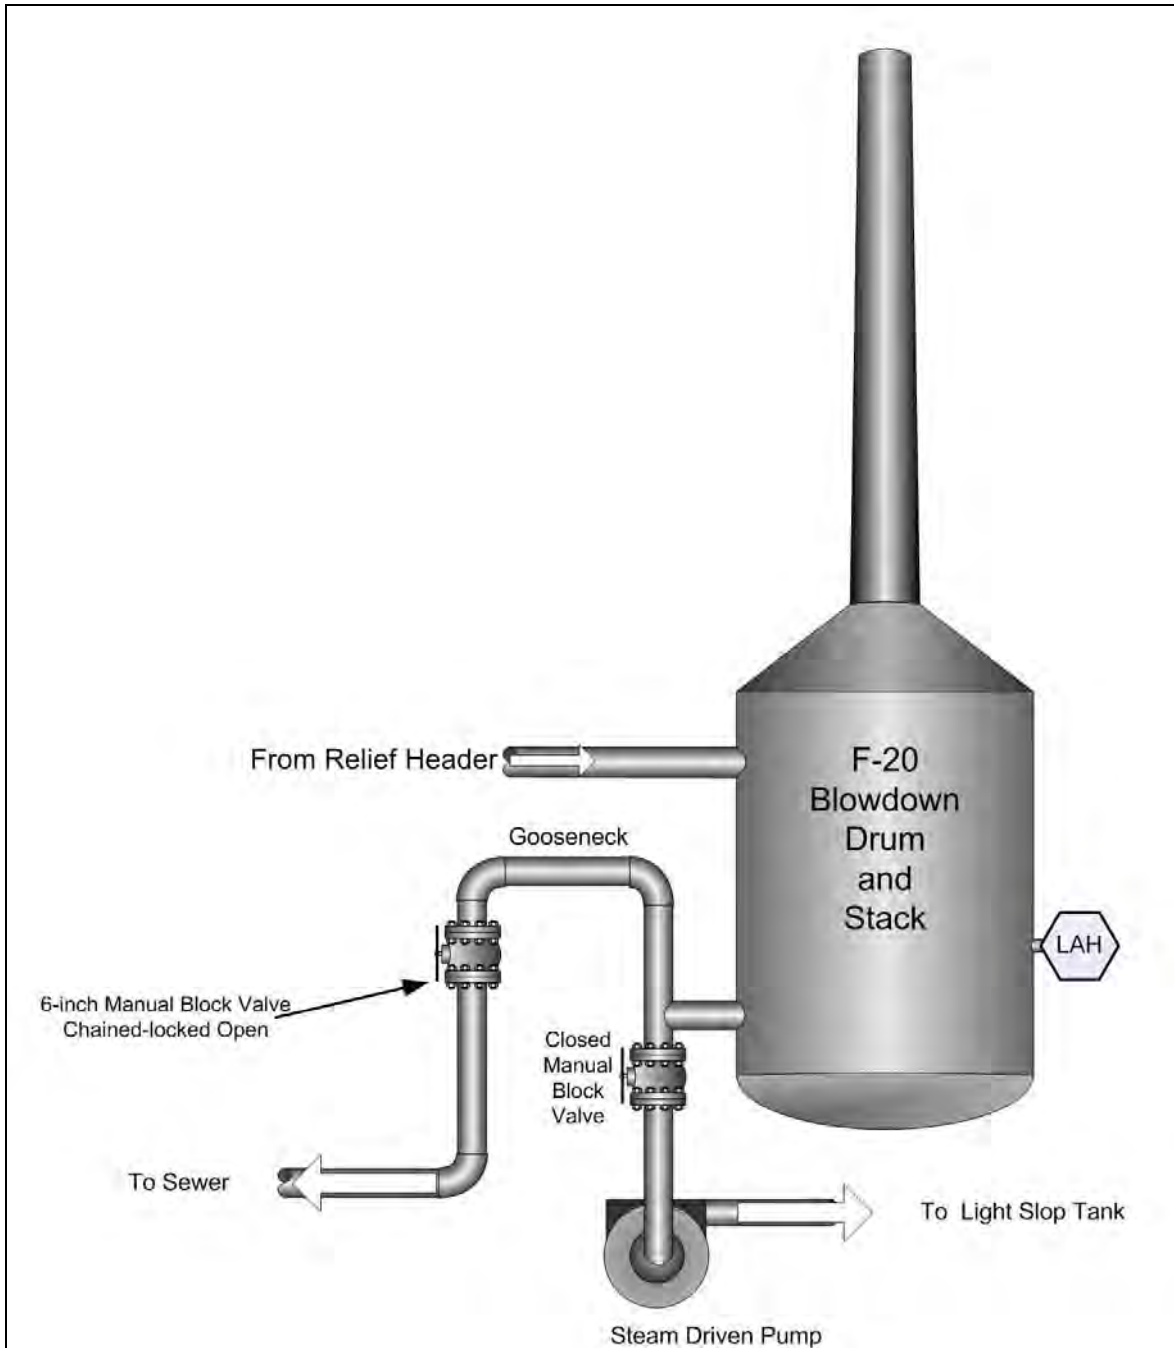
Figure 3. Blowdown drum and gooseneck

A liquid level, normally water, was maintained in the bottom of the blowdown drum. The height of this level was controlled by a "gooseneck" seal leg piped to a closed drain (Figure 3 and 4).

As the blowdown drum and stack filled, some of the flammable liquid flowed into the ISOM unit process sewer system through the chained-open 6-inch NPS manual block valve (Figures 3 and 4) and the other safety relief valve discharge pipe headers. As explained in section 2.2.5, this practice of discharging to the sewer was unsafe.

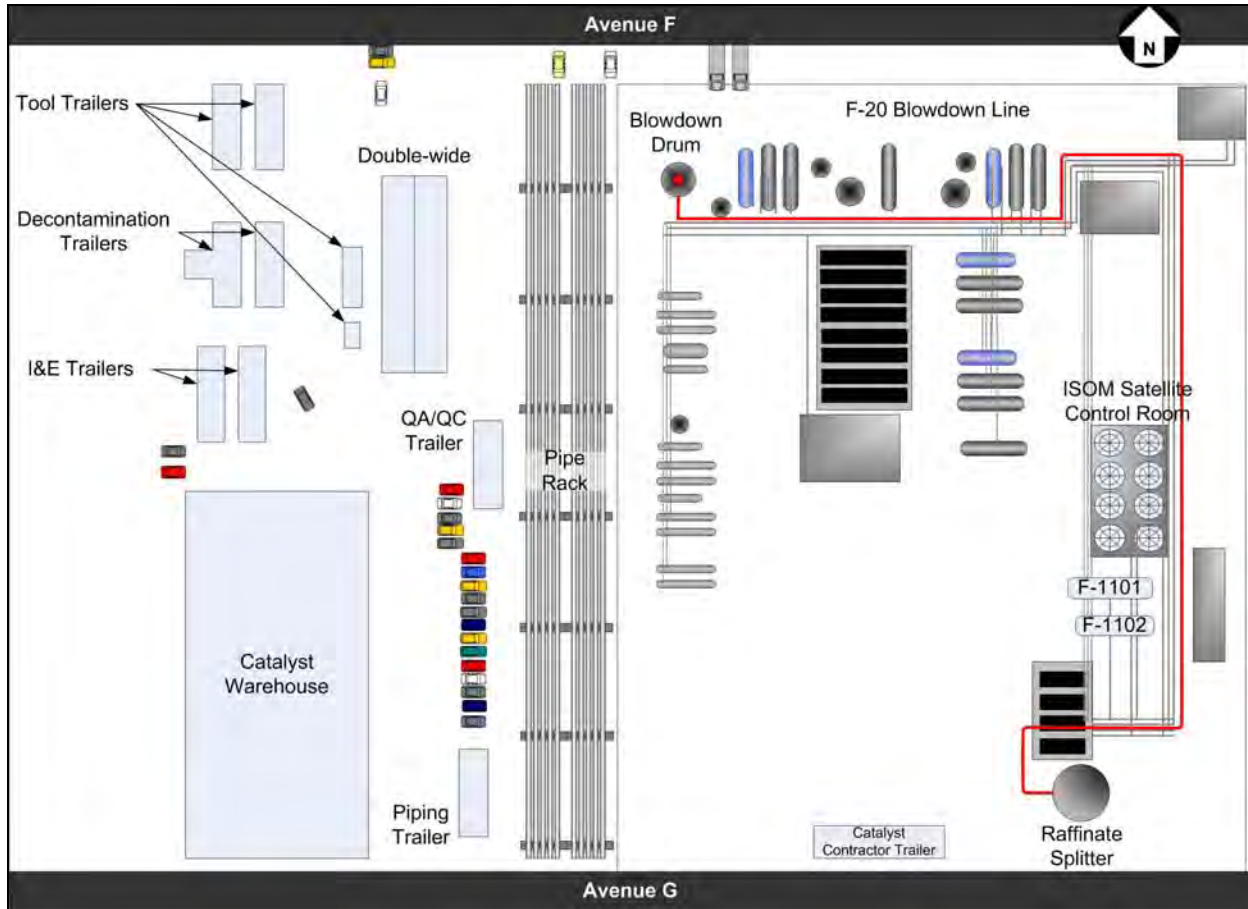
Figure 15. Trailer area and adjacent ISOM unit

BP's placement of occupied trailers close to the ISOM unit was a key factor leading to the fatalities from this disaster. All 15 who died during the March 23, 2005, incident were in or around trailers. The trailers were sited in this area primarily for convenience: the unoccupied area between the ISOM and NDU units was selected because it was across the road from the Ultracracker, (ULC) and would be a convenient staging area for the contractors in their turnaround work (Figure 15). The CCPS noted that this practice is an increasing trend:

While planning for the 2005 ULC unit turnaround, in September 2004 BP sited a double-wide trailer between the NDU and ISOM to house employees for the Motorization Project. Nine others were located in the same area to support the ULC turnaround, but a MOC was not conducted for any of them despite being required by BP policy (Figure 15). (Appendix F provides further information on the location, construction, and use of all the trailers sited in this area.)

In light of these findings and because API 752 is commonly used as a basis for facility siting, the CSB made an urgent recommendation to API regarding trailer siting and recommended either revising API 752 or issuing a new standard to address the issues (Appendix C).

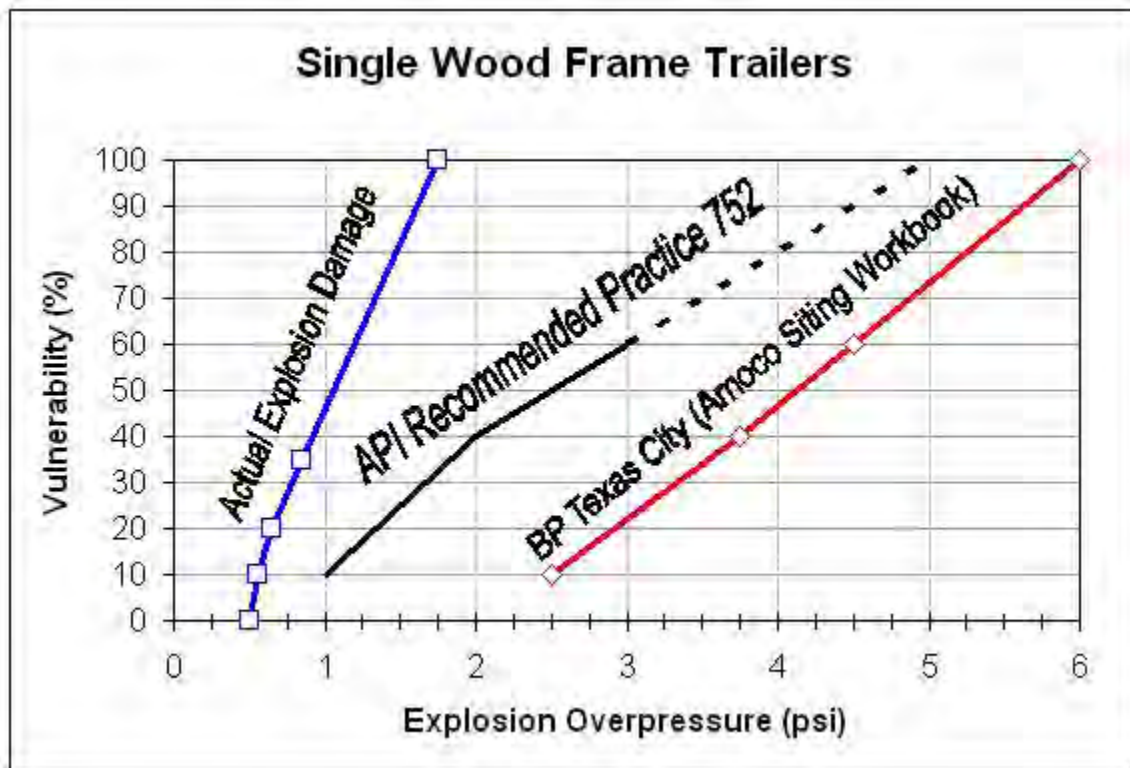
Figure 16. Comparison of explosion damage based on API and BP Texas City criteria

mid-1990s (Fryman, 1996). In fact, the facility siting analysis was revalidated in 2002 using the Amoco workbook, even though the BP Group had adopted and published a new group risk criteria (Mogford 2005, pg. 98). The workbook generally follows API 752 (1995), but contains some differences (Appendix F.1.1) that made it less protective (see additional discussion in Section 6.4 and Figure 16). The workbook sets forth a methodology for assessing risks involved in locating buildings with respect to process. Although the limitations of this workbook (e.g., potential for trailer damage from a vapor cloud explosion and annualized occupancy of highly populated, short-duration turnaround trailers) were pointed out in a September 2004 email forwarded from the Whiting refinery to the Texas City PSM manager, these limitations were dismissed because the MOC PHA checklist for temporary trailer siting called for a distance of 350 feet (107 m) from the process, and at that distance the risk of a fatality was extremely low. However, the 350-foot (107 m) distance triggered a need for an analysis, but did not prevent a trailer from being placed closer than 350 feet (107 m).

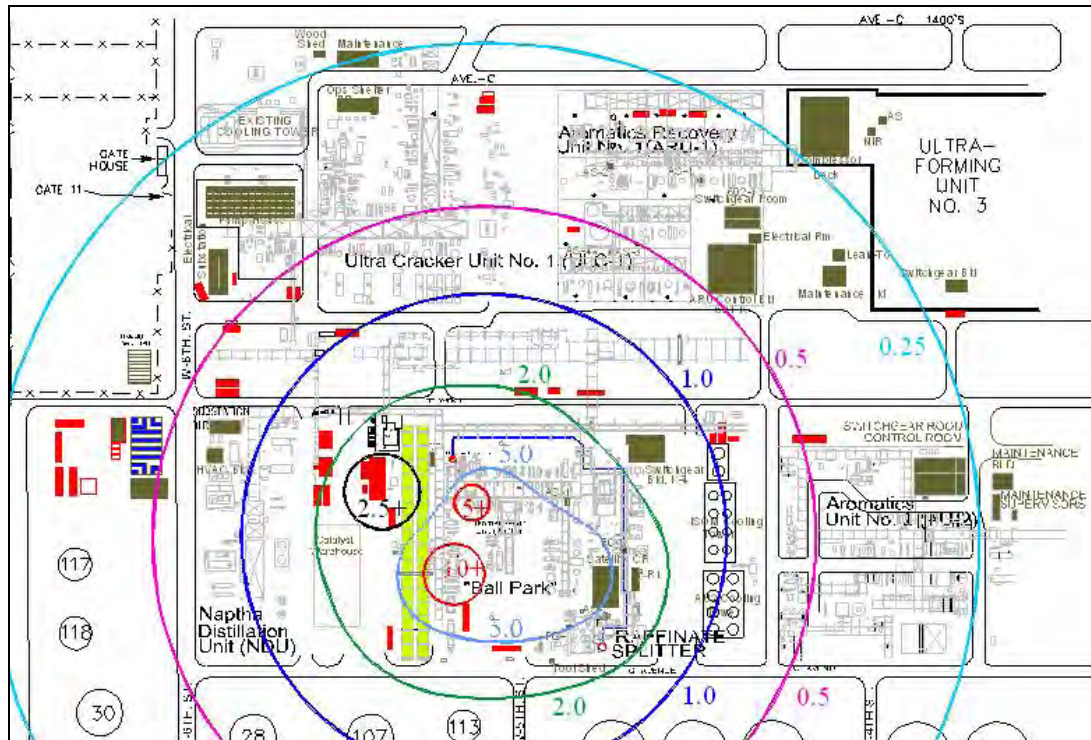
Figure H- 2. Blast overpressure map

The blast overpressures presented on the map are free-field values and do not address blast wave reflections. Objects facing the blast can experience applied blast wave pressure higher than the free-field values.

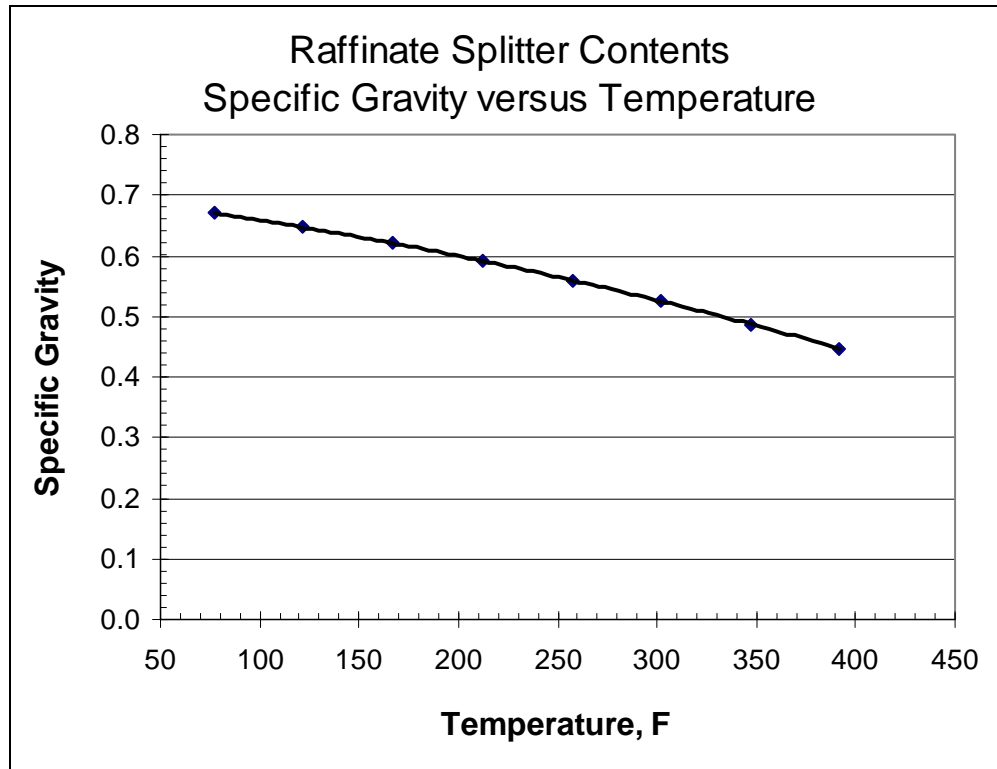
The specific gravity of the hydrocarbon liquid in the raffinate splitter tower is strongly temperature-dependent. At 300°F, the temperature in the base of the raffinate splitter when it overflowed, the specific gravity is about 0.55 (Figure S-2). As Figure S-1 shows, at a specific gravity of 0.55 the transmitter would indicate a level of 78 percent when flooded, which matches the value observed when the raffinate splitter tower over-filled. The CSB concludes that the level transmitter was not calibrated for the specific gravity of fluid at its normal operating temperature.

The CSB investigators learned that the instrument data sheet, which should have been used for calibrating the transmitter, had not been updated since 1975 when the tower was part of a different process with a different feed fluid. The data sheet had never been changed to reflect the operating specific gravity in the ISOM process; furthermore, instrument technicians responsible for maintaining and calibrating the transmitter stated that the data sheets—even if they had been updated—were unavailable to them. The CSB learned that these data sheets were filed in an engineer’s office and were not typically given to technicians with work orders for instrument calibration.
