# **FINAL INVESTIGATION REPORT**

## **CARIBBEAN PETROLEUM TANK TERMINAL EXPLOSION AND MULTIPLE TANK FIRES**

### **CARIBBEAN PETROLEUM CORPORATION (CAPECO)**

REPORT NO. 2010.02.I.PR

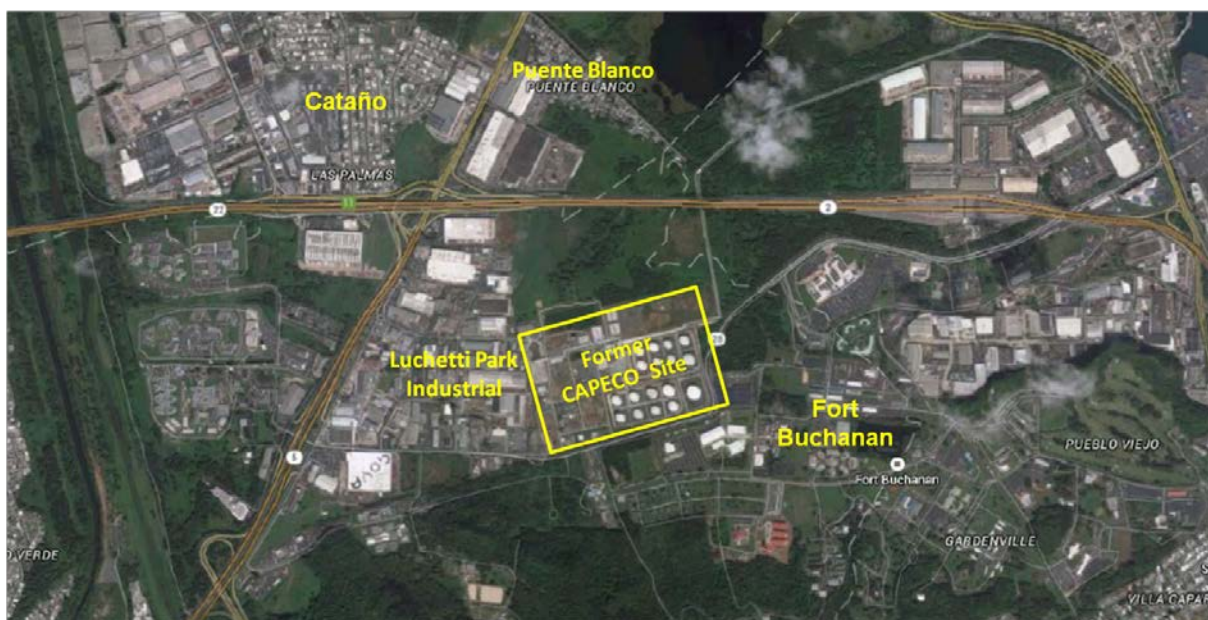
Figure 9: Communities neighboring the CAPECO facility

The incident caused the governor of Puerto Rico to request federal assistance, and on October 24, 2009, the President signed an emergency declaration<sup>29</sup> providing assistance for the municipalities of Bayamón, Cataño, Guaynabo, San Juan, and Toa Baja (Figure 9). The federal emergency declaration activated 17 FEMA Emergency Support Function Annexes (ESF)<sup>30</sup> and enabled FEMA to provide logistical support, Direct Federal Assistance (DFA), and public assistance grants to state and local municipalities.<sup>31</sup> Logistical support included setting up a more

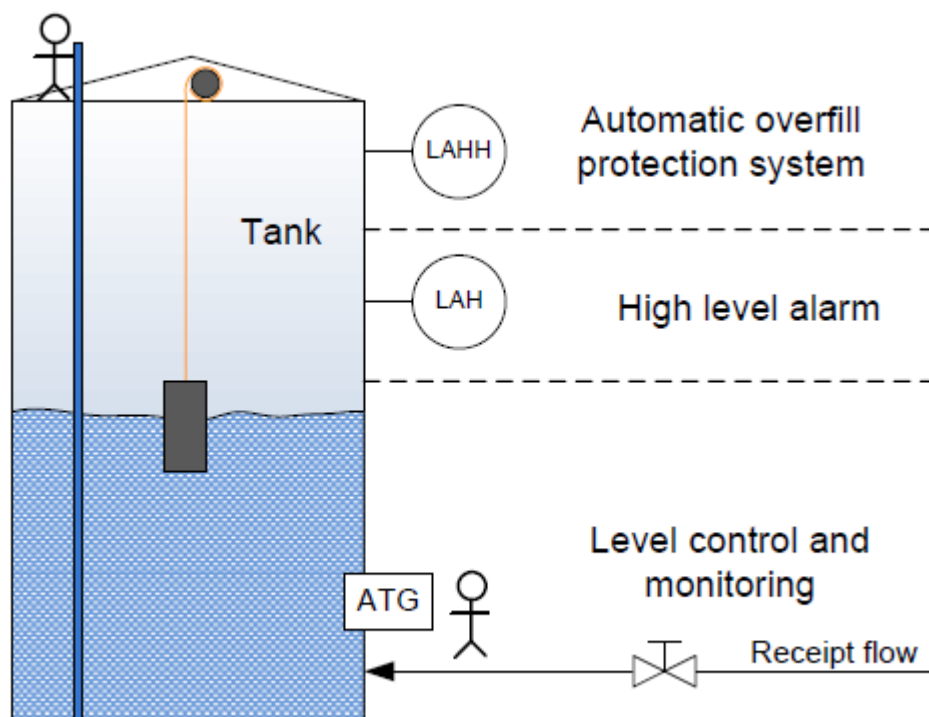
Figure 13: A comprehensive overfill prevention system includes the ATG, high-level alarm (LAH), and automatic overfill protection system (LAHH), in addition to the operator and facility procedures that govern, monitor, and control the flow of fuel into a tank.

CAPECO lacked a reliable automatic level control and monitoring system for measuring tank levels. (See Figure 13.) The automatic gauging system at CAPECO, described in Section 3.6.3, had a history of repeated failures and prolonged out-of-service periods. On the night of the incident, the float and tape device inside Tank 504 became stuck and the transmitters for Tanks 107 and 409 were not receiving data from the side gauge on Tank 409; therefore, data on the tank liquid level and a calculated fill rate into 409 were not available in real time on the computer. The computer monitoring system was often compromised by outages from lightning strikes and accidental breakage of the computer cables after maintenance activities in the tank farm area. In addition, the transmitters<sup>56</sup> that sent the data to the computer were also susceptible to electromagnetic interference and frequently needed replacing after lightning storms.

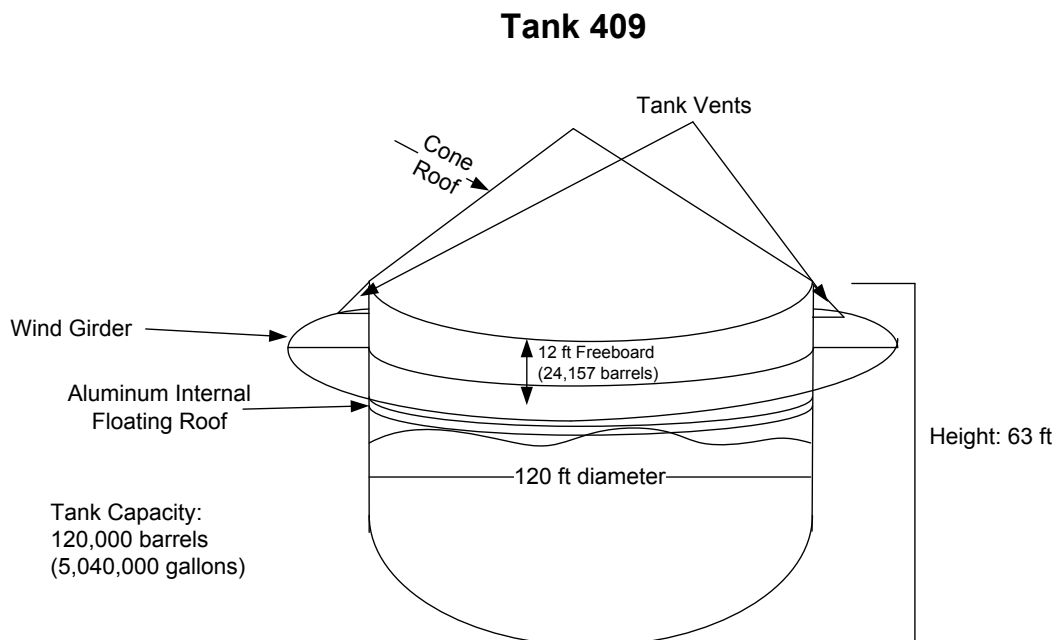
Figure 14: Tank 409 Specifications

Tanks 409 and 410 were located within the same secondary containment dike.<sup>23</sup> Similar to the Buncefield incident,<sup>24</sup> during the overflow, gasoline sprayed from the tank vents, hitting the Tank 409 wind girder and aerosolized,<sup>25</sup> forming a vapor cloud.<sup>26</sup> A CSB topographic survey of the site shows that Tanks 409 and 411 were located at the highest point within the tank farm area, allowing the vapor cloud to spread to lower lying areas in the direction of the WWT (Figure 7). See Figure 14, Tank 409 Specifications.

The destruction of the Tank 409 internal floating roof in the explosion prevented the CSB from determining if it failed during filling operations. Therefore, internal floating roof failure might have contributed to the overfilling of Tank 409. The roof construction of Tank 409 was subject to numerous operational limitations. Tank 409 had a fixed cone roof with an aluminum internal floating roof (IFR), and a freeboard<sup>71</sup> of 12 feet (24,157 bbls). (See Figure 14 for Tank 409 specifications.) Aluminum IFRs are prone to corrosion when exposed to caustic liquids but sufficient for petroleum and organic materials. An internal floating roof can fail by means of turbulence,<sup>72</sup> roof submersion,<sup>73</sup> seal issues, and fatigue.<sup>74</sup>
