Flashing of Hydrocarbons

EPSC Learning Sheet , November 2018

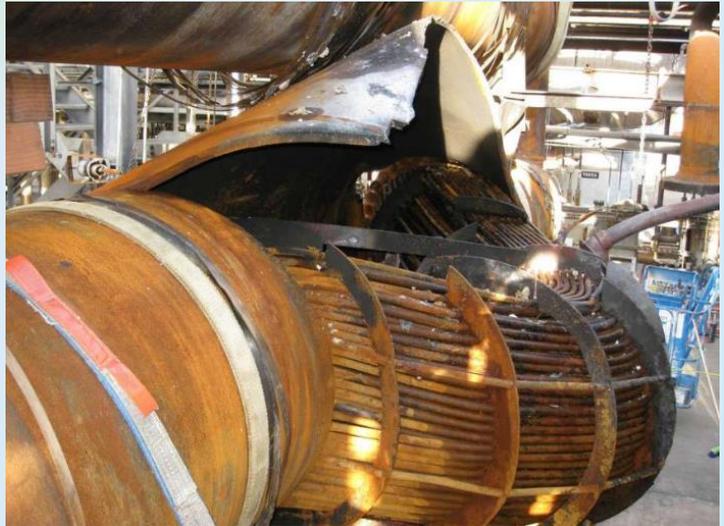
A carbon steel heat-exchanger reached $-40\text{ }^{\circ}\text{C}$ due to flashing of propylene. It was depressurized after a trip, and restarted (pressurized). It ruptured open and an explosion and a serious fire took place.

- Depressurising (flashing) of C₂, C₃ hydrocarbons can result in low temperatures, where plain carbon steel becomes brittle
- Never pressurise equipment when being below its design temperature: due to the stress of the brittle steel at low temperature it can break catastrophically (see picture)
- Include flashing scenarios in the PHA and define measures
- Measure impact strength at low temperature of the specific steel batch used (in design phase), in case the equipment can auto-refrigerate by flashing
- Validate the mechanical integrity by an inspection expert when equipment has gone below its design temperature, before using it again
- Train auto-refrigeration scenarios with operators
